Portpatrick Old Church, Portpatrick, Dumfries and Galloway

Building record

May 2015

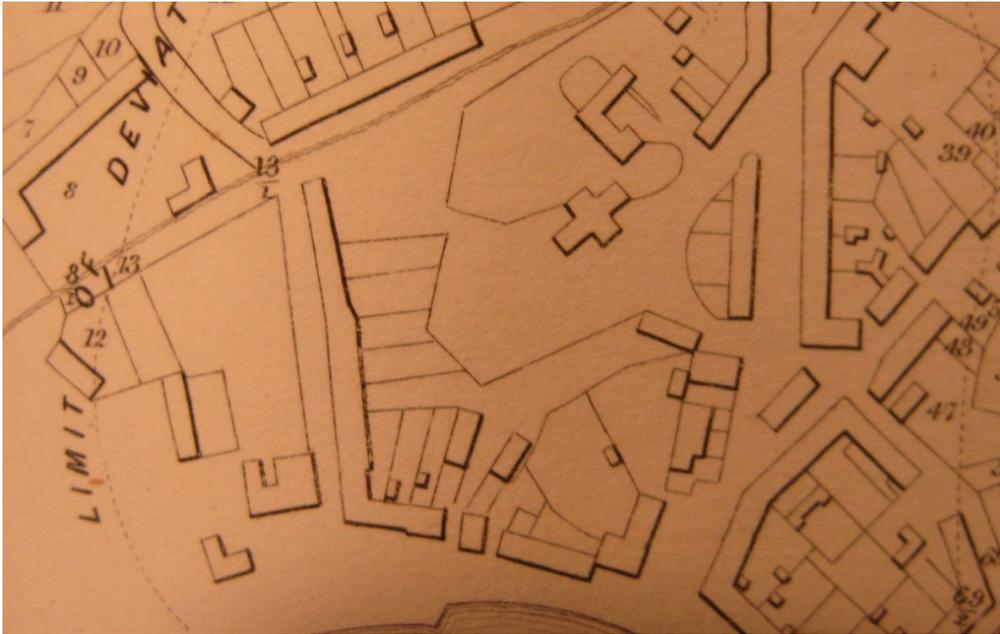
1. Extract from the British Irish Union Railway map of 1845

The first accurate, large scale survey of the village is contained in the 'Plan and section of a proposed railway from Dumfries to Portpatrick to be called the British and Irish Union Railway' surveyed in 1845 (Stranraer Museum: WIWMS WCC/4/3 and Fig.1). The map of the final section of the proposed line contains an inset plan of the village which includes the outlines of the church, graveyard and manse. The boundary wall around the graveyard is also shown with an apparent entrance or break to the north-west suggesting that there may have been access to the graveyard from Blair Terrace. Interestingly, no boundary wall is shown on the west side of St Patrick Street which is the site of the modern entrance into the graveyard. This is curious as the wall is shown on a sketch of 1811 (see Hutton's sketch below). Either the wall had been demolished by the 1840s or the 1845 map is inaccurate.

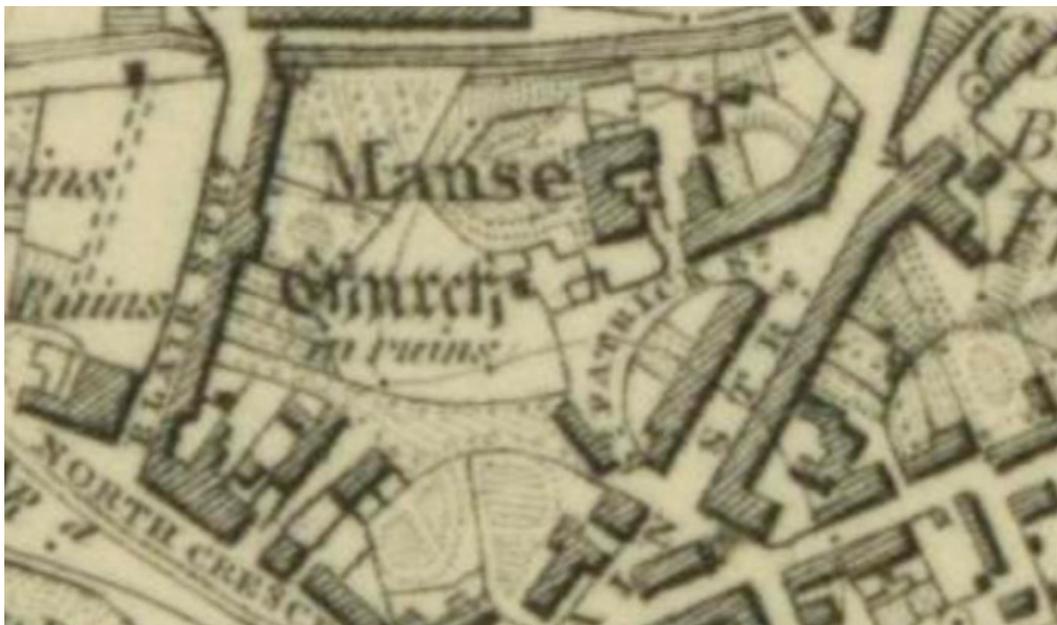
2. Extract from OS six-inch map of 1849

The First Edition Ordnance Survey six-inch map of the Portpatrick area (Fig. 2) was published in 1849 and is based on survey work undertaken during 1847-48. The central and east sections of the church are shown in outline (signifying an unroofed structure or ruin) but the west end is shaded which means this part of the building was roofed. Curiously, the tower is not depicted. The graveyard boundary is shown as a complete enclosure with exactly the same outline as survives today. The map also shows a small square enclosure to the south-east of the church in what is now the manse garden and depicts a long narrow building at the southern end of St Patrick Street with one end close to the south-east corner of the graveyard boundary wall.

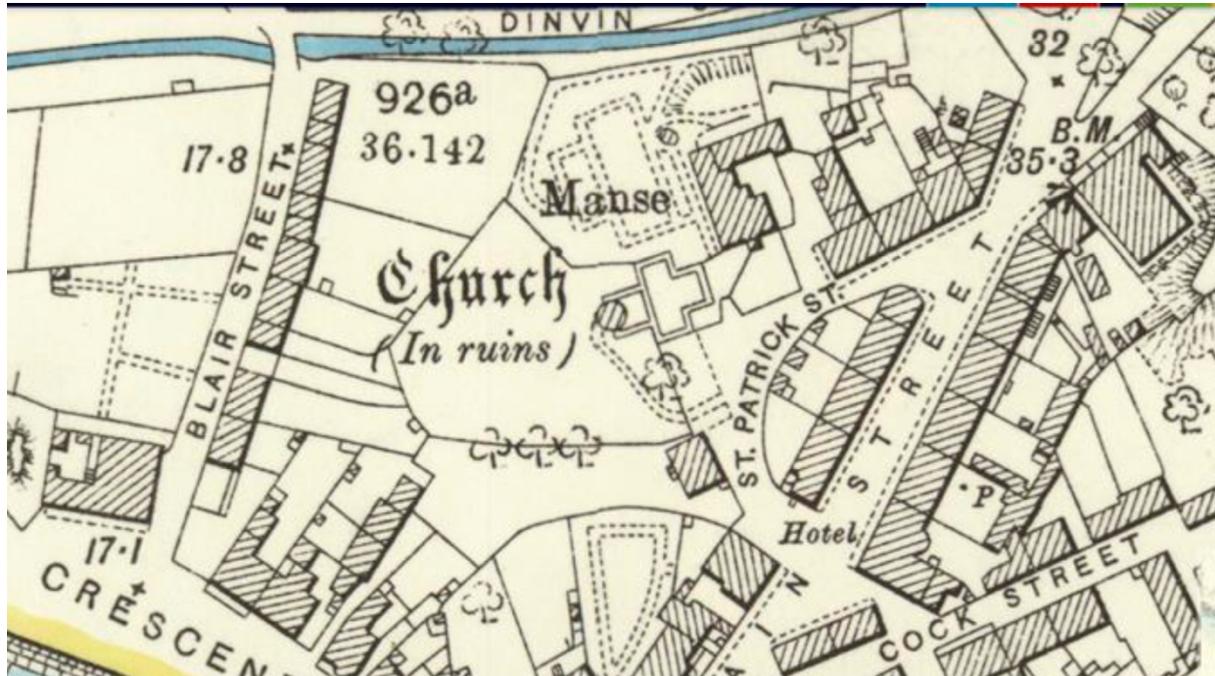
3. Extract from the OS 25-inch map of 1894.

The 1894 25-inch Ordnance Survey (Fig. 3) map depicts the site in more detail but shows little change to either the church or graveyard since the 1849 survey. The tower is marked as a roofed structure and the church is shown unroofed. The cross wall at the east end of the west transept is also marked. There are some minor alterations to the layout of the manse garden, there is a new building on St Patrick Street close to the south-east corner of the graveyard wall and there have been some changes to the garden walls between the graveyard and Blair Terrace.

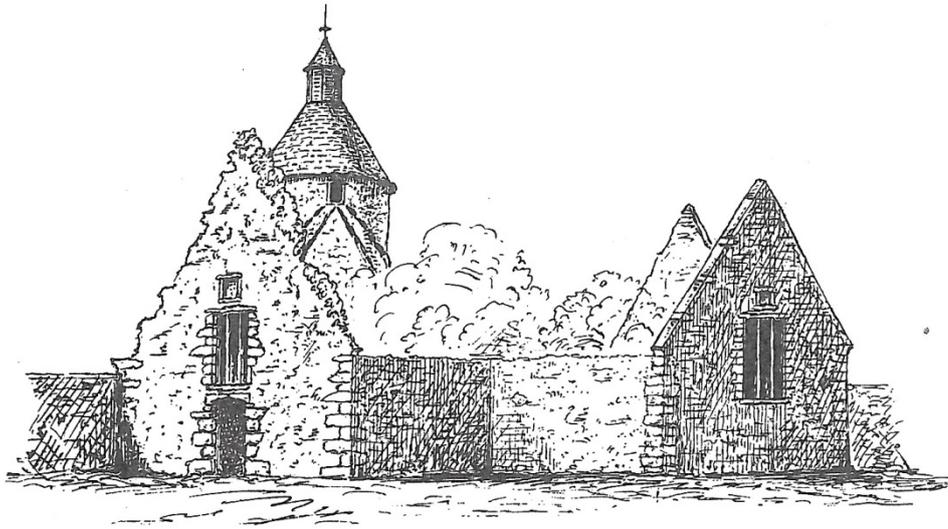
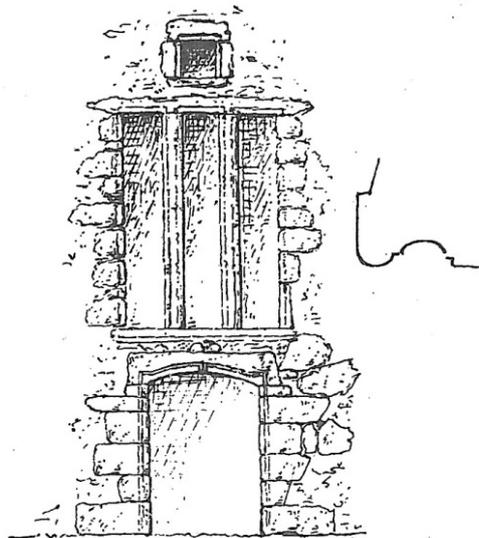
5. *General view of church and detail of south door from MacGibbon and Ross, 1892*

The curious round tower and the church's cruciform plan have attracted the attention of a number of historians and architects. The earliest and one of the most detailed accounts is in McGibbon and Ross's 'Castellated and Domestic Architecture of Scotland' published in 1892. This includes a full description with dimensions, a measured plan and two sketches (Fig. 5). The window mullions are described as 'away' but are shown – presumably as reconstructions – in both sketches. The sketch elevation of the doorway is particularly interesting as it shows the moulded lintel above the door; this feature is now lost. Mc Gibbon and Ross (1892:193) describe the tower as a 'singular structure – quite riddled with windows' and remark 'there is a prevailing belief that it was built as a lighthouse

FIG. 1308.—Portpatrick Church.
Elevation of Doorway, &c.

The main entrance is in the south gable and comprises a centrally placed door, 1.2m wide and 2m high with red sandstone margins. Above is a centrally set rectangular window with regular sandstone margins (Fig. 9). The door lintel and window sill are absent but the MacGibbon and Ross illustration of 1892 (Fig. 5) shows the lintel as having a slightly concave bottom edge and incised line decoration very similar to the surviving lintel on the west door in the north transept and the first floor window in the east face of the tower. In the gable space is a recess with sandstone margins, probably for a coat of arms. There is a similar recess in the centre of the east gable. The wall head on the south gable is incomplete but well-cut sandstone skewputs survive at eave level and there are cut sandstone quoins beneath.

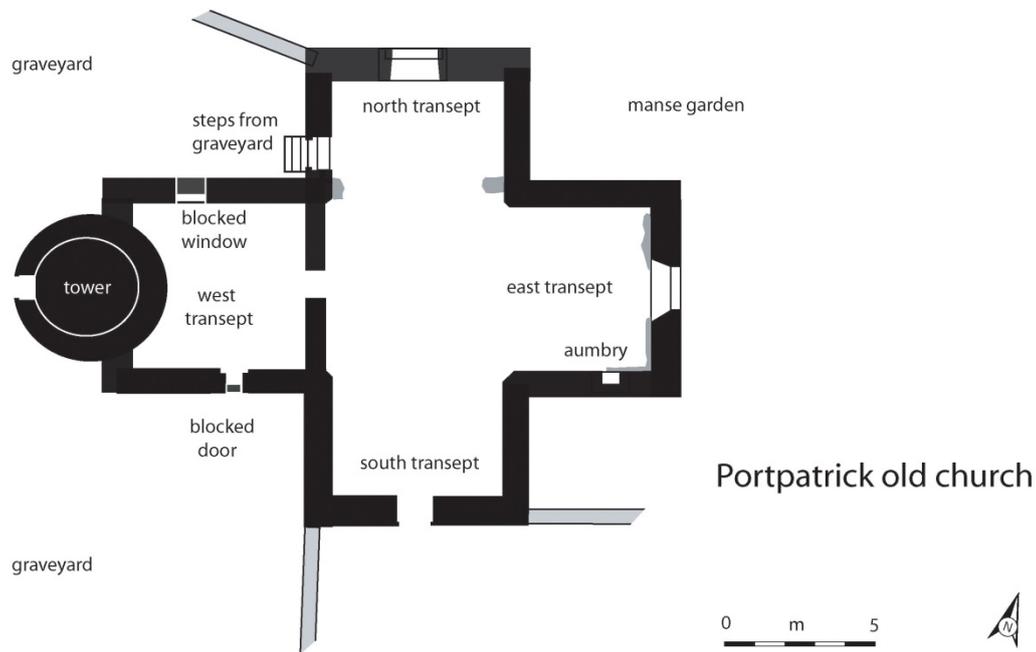
6. Plan of church

The church is cruciform in plan with a four-storey round tower at the west end (Fig. 6). It comprises four transepts and internally measures 17.4m east to west and 14.5m north to south. The tower is 2.8m diameter within a wall 1.1m thick. Both the church and tower are local greywacke in random rubble construction and the skews and window and door surrounds are sandstone.

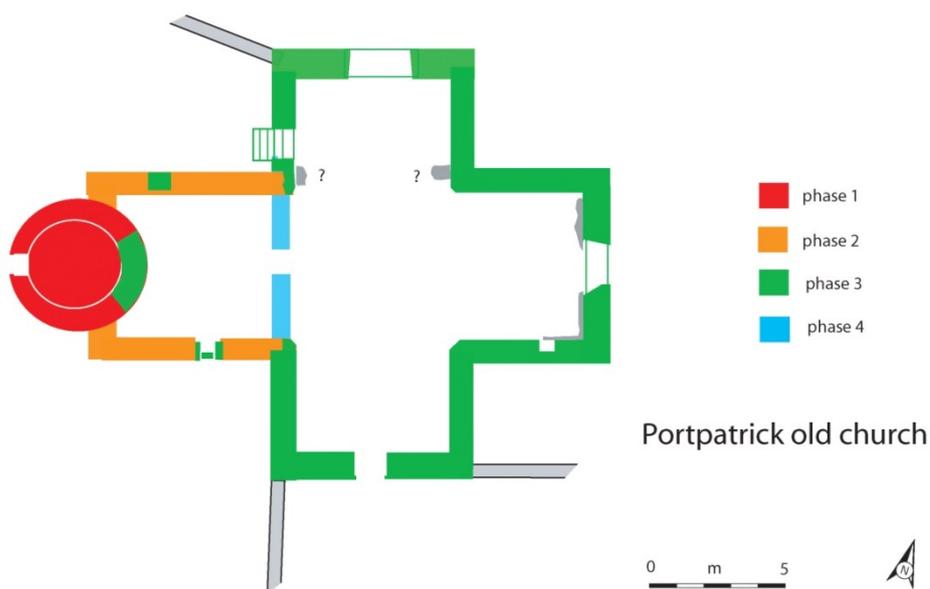
8. Possible building phases

An initial examination of the fabric of the church and tower suggests a number of possible building phases (Fig. 8). Phase 1 relates to the construction of the tower, probably in the 16th century; it may have been free standing or attached to a now demolished building. Phase 2, represented by the west transept, relates to a building attached to the tower and probably dating from the later 16th century. Phase 3 is the construction of the main church in 1628-29 and includes the replacement or construction of window(s) on the tower's east face; the other tower windows may also date from this phase. Phase 4 is the construction of the internal cross wall, probably during the later use of the church.

More detailed examination and survey of the building would help to refine these phases.

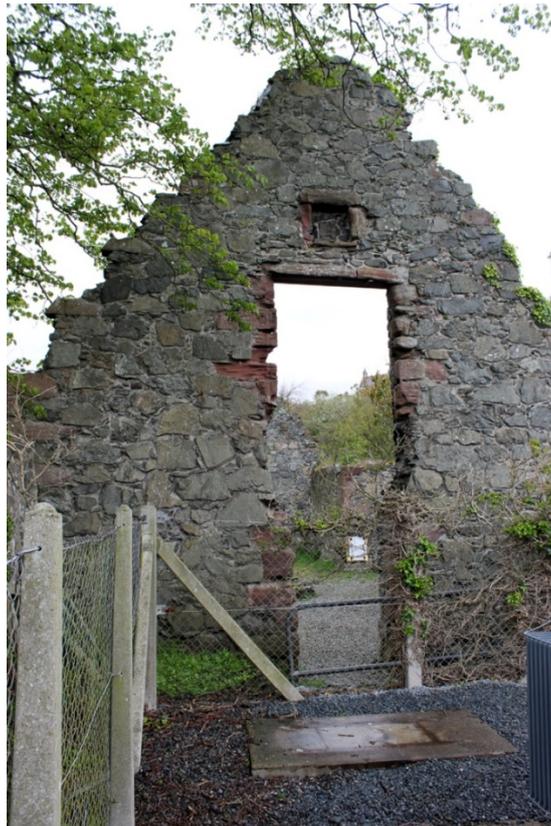
9. South gable with window & doorway.

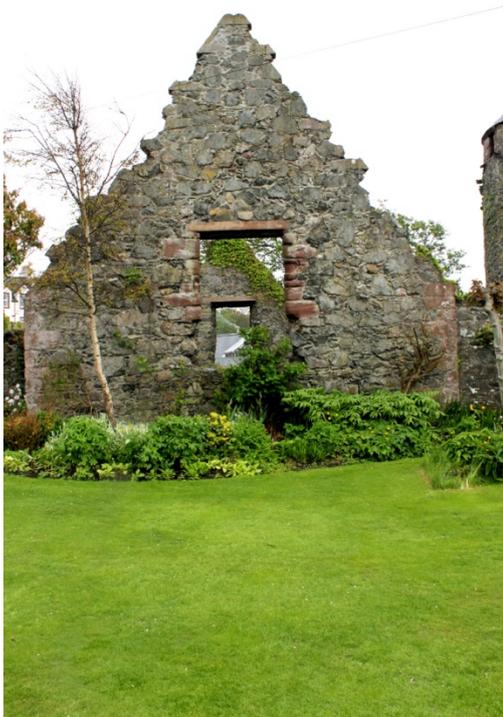
The north and east gables follow a similar design with large, centrally set windows (Figs. 10 & 12). The best preserved is the north gable where some of the plain sandstone skewers are still in place as are the sandstone ridge stones at the gable top. Skewputs survive on all corners (Fig. 11) and the one on the southern corner of the east gable has the carved date 1629. In the west wall of the north gable is a doorway, 2.3m high x 1m wide, with set of stone steps leading from the graveyard into the church (there is a difference in height of almost 1m between the church interior and the graveyard). The doorway has sandstone margins and an intact sandstone lintel with a concave underside.

10. North gable

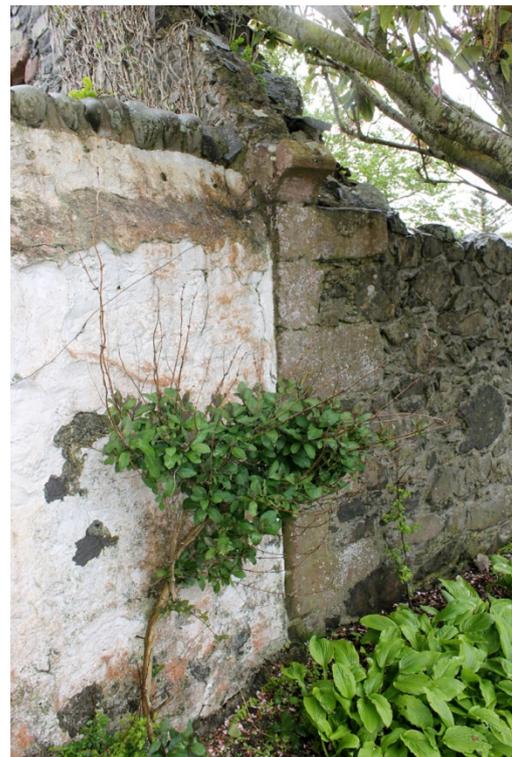
11. North-east corner of east transept

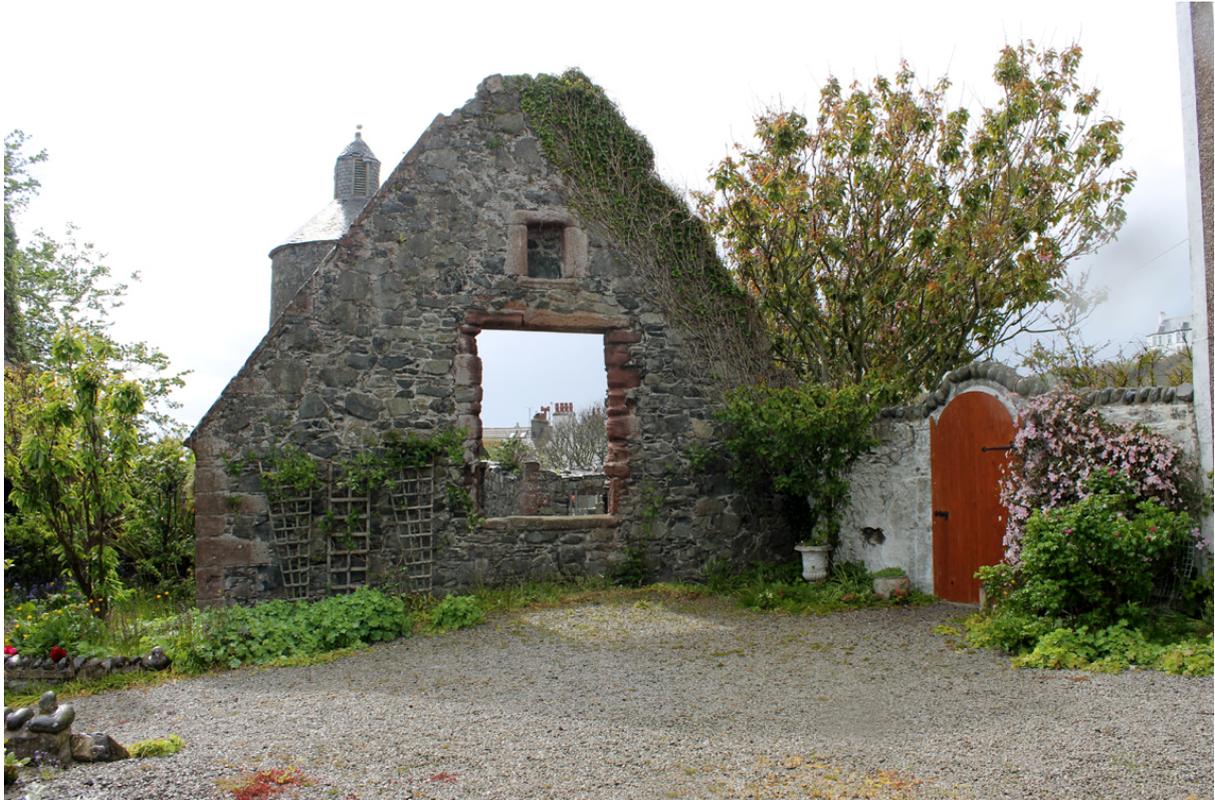
12. East transept with window and heraldic recess.

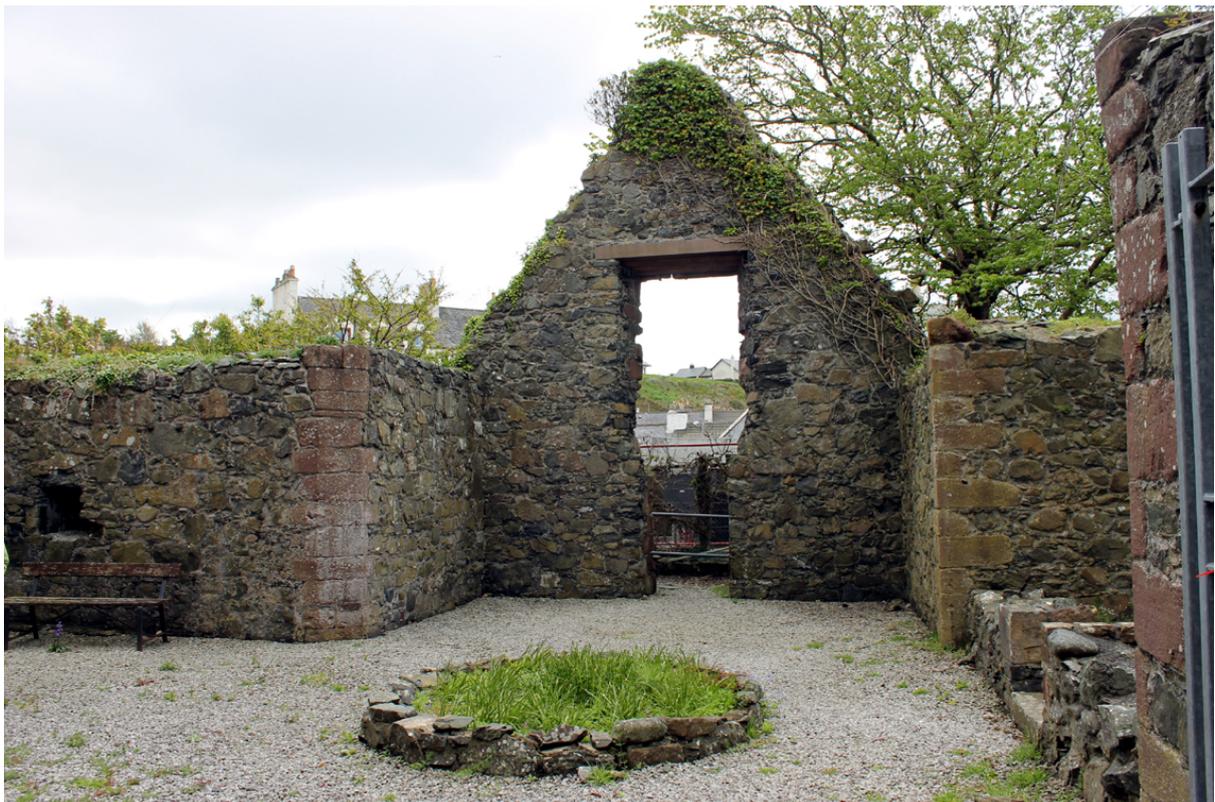
The floor of the west transept is 0.17m higher than the rest of the church interior and there is a low cross wall with a central doorway at the east end of the west transept. In the south wall of the east transept is a rectangular recess (0.56m x 0.50m x 0.4m deep) which probably one held a wooden cupboard or aumbry (Fig. 13). The inner corners or crossings of the transepts are quoined sandstone with chamfered faces and stepped chamfers at the bases (Figs. 13, 14 & 15).

13. Internal view of south transept with doorway and window. Aumbry in east transept to left.

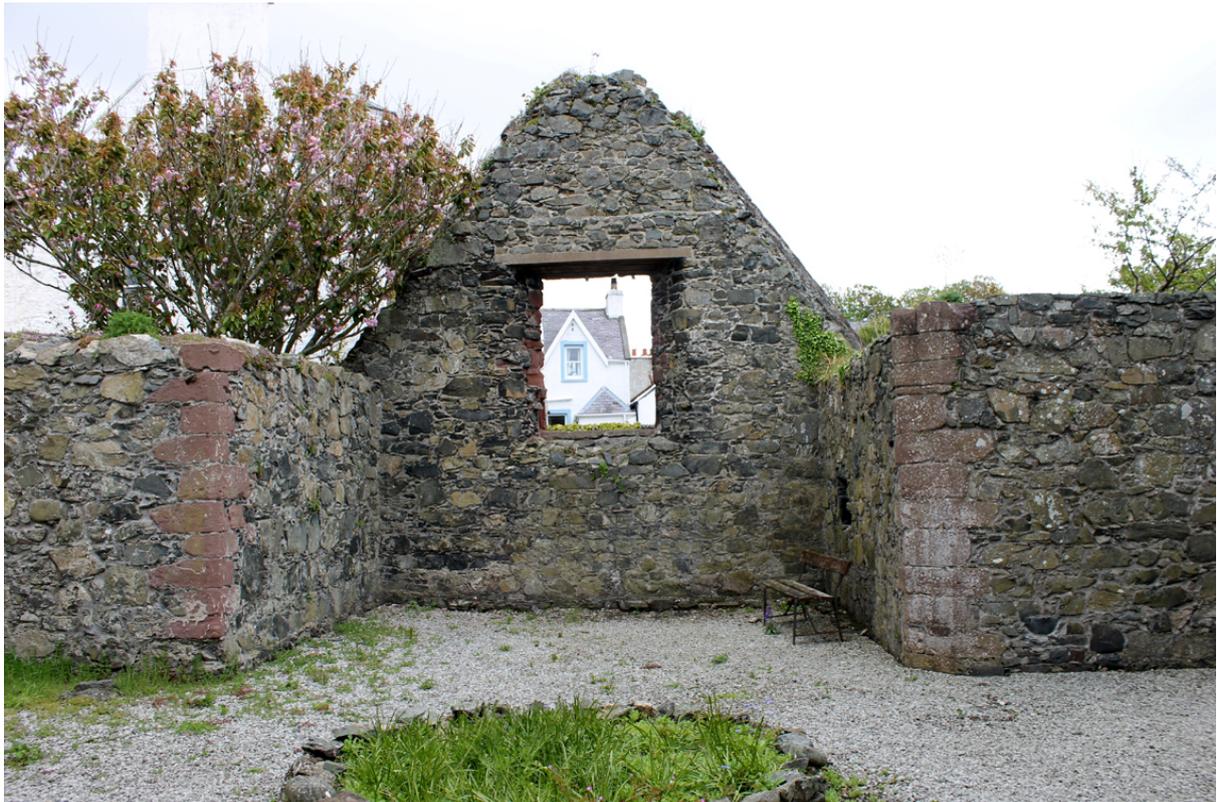
14. Internal view of east transept.

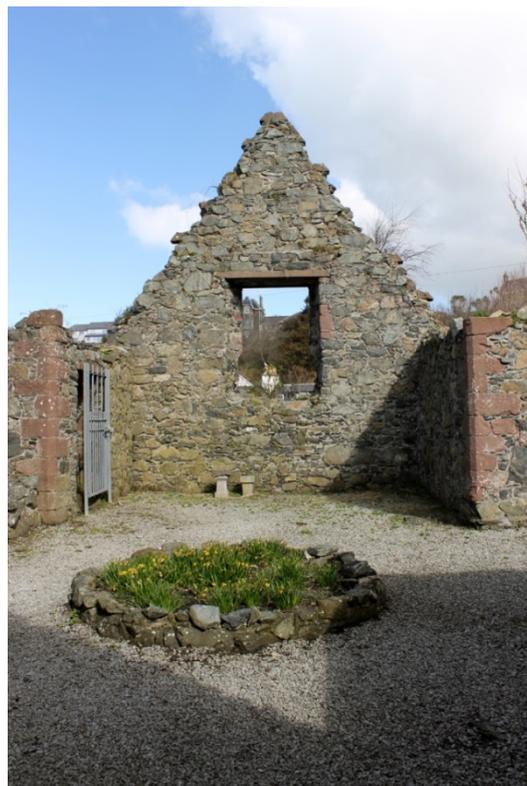
15. Internal view of north transept. Door to graveyard on left.

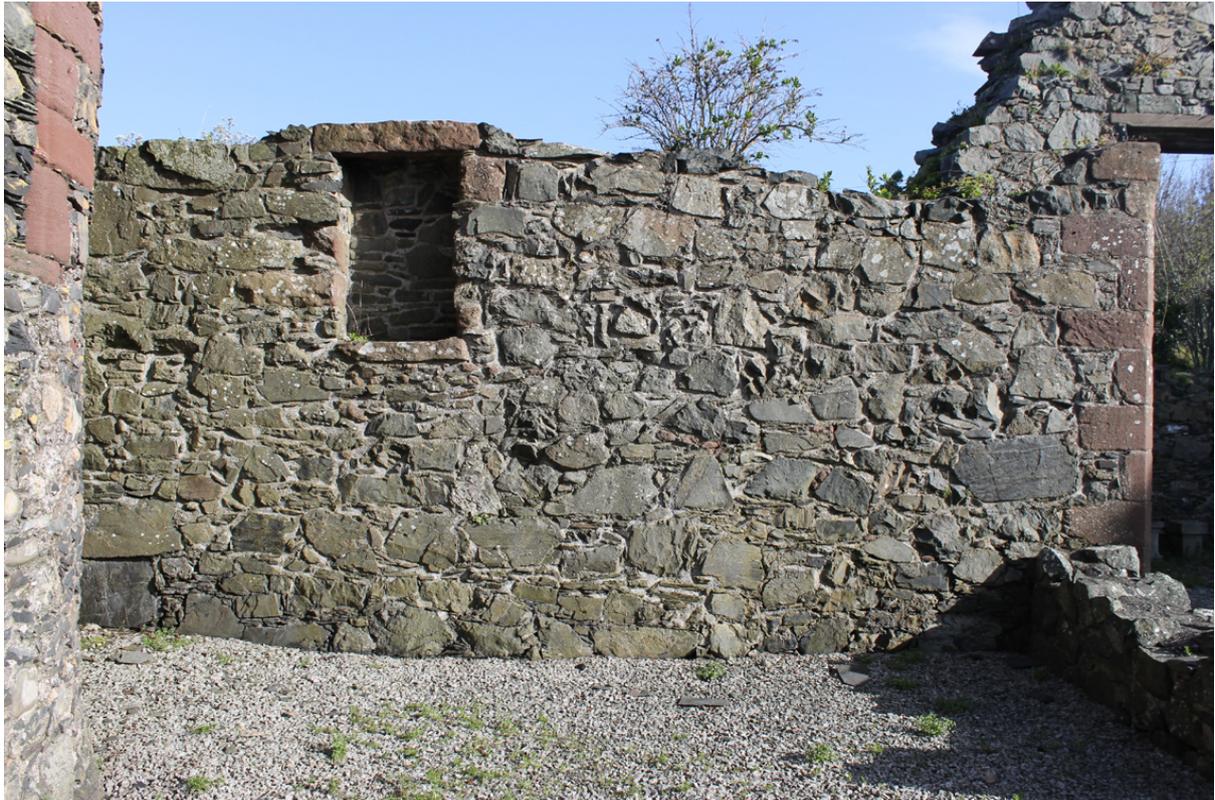
The west transept is built against the tower and the two short connecting walls at the west end are in dressed red sandstone with narrow moulded windows under the eaves. In the south wall is a blocked door, 1.9m wide x 0.8m wide (internal measurements) with an intact lintel which is covered by a repositioned 17th century grave slab. In the north wall is a blocked rectangular window, 1.14m x 0.7m, which has been used as a recess for a vertically set grave monument dated 1770.

16. North wall of west transept with blocked window.

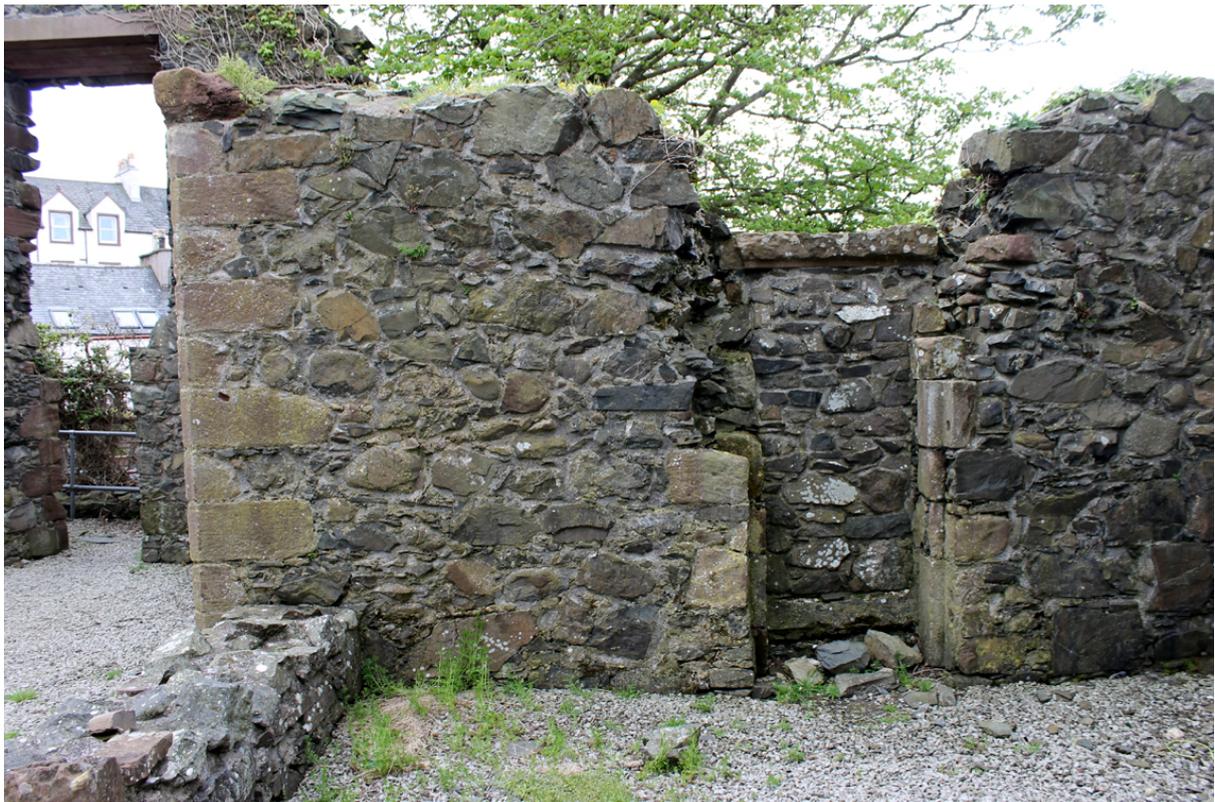
17. South wall of west transept with blocked doorway.

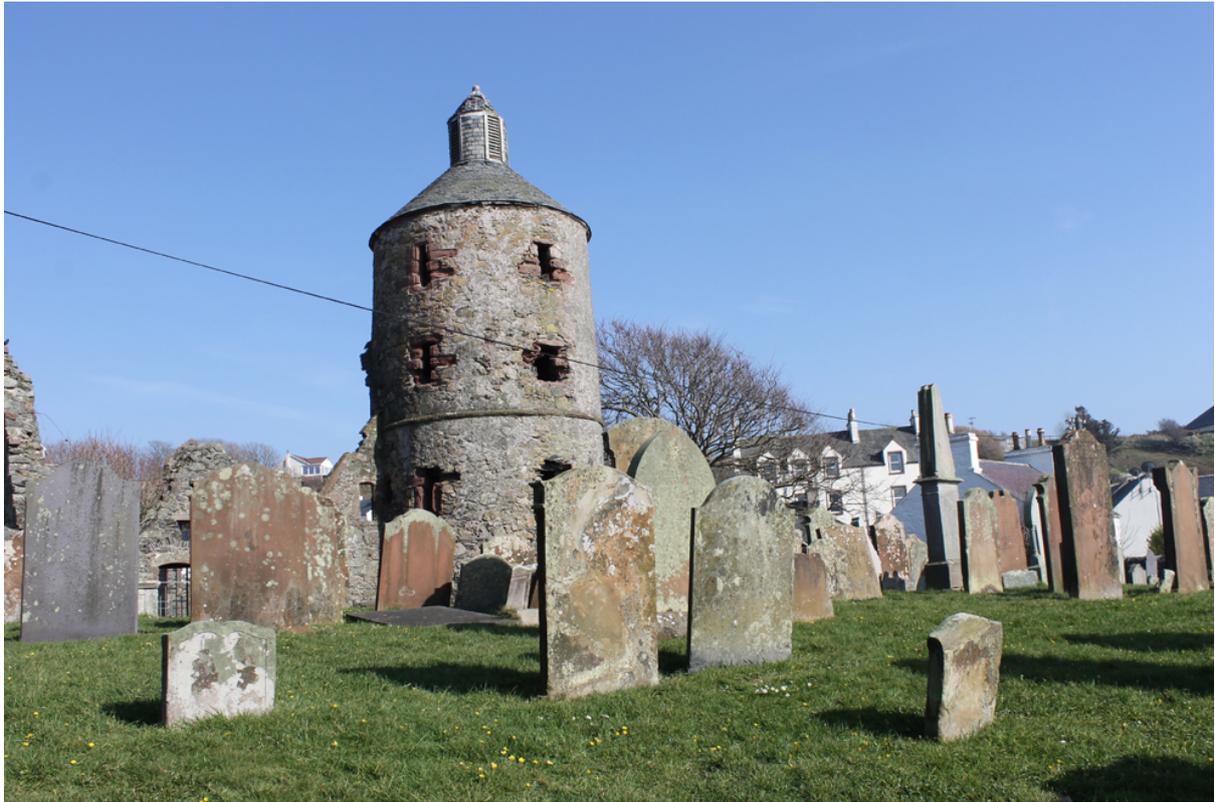
The tower is four storeys with a conical slate roof topped by a slated cupola with wooden louvres. At the second floor is a moulded stone string course. There is a ground level door to the north leading into the graveyard and above this are three windows, one to each level. All the windows and doors have moulded, red sandstone surrounds. The surrounds are very worn and the external lintel above the door is now missing. To the north-west are a further three windows on the first, second and third floors and a similar set of four windows with an additional second floor opening on the south-west side of the tower. A small additional first-floor window on the north-west appears to be partly overlain by the northern return wall of the west transept and this is the best structural evidence for the tower being earlier than the church (Fig. 22). Traces of harling survive on the tower.

18. View of tower from north-west.

The church is in fair condition although some saplings have taken root on the wall heads of the west transept. The tower, however, is in need of consolidation. The front lintel on the west door is absent and the door's stone relieving arch, although appearing in good condition, is unsupported. The stone surrounds on the first-floor window above the door are absent and a number of other windows on the tower are also missing their lintels. The main roof appears complete but slates are missing from the cupola and this means that the internal timber roof structure is at risk from weathering and rot. The interior condition of the tower is unknown.

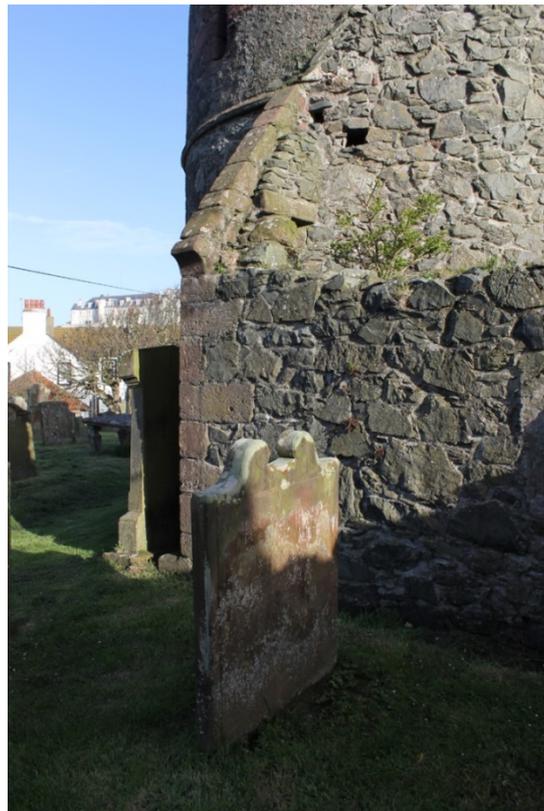
19. South-west corner of west transept with skewput. Tower beyond.

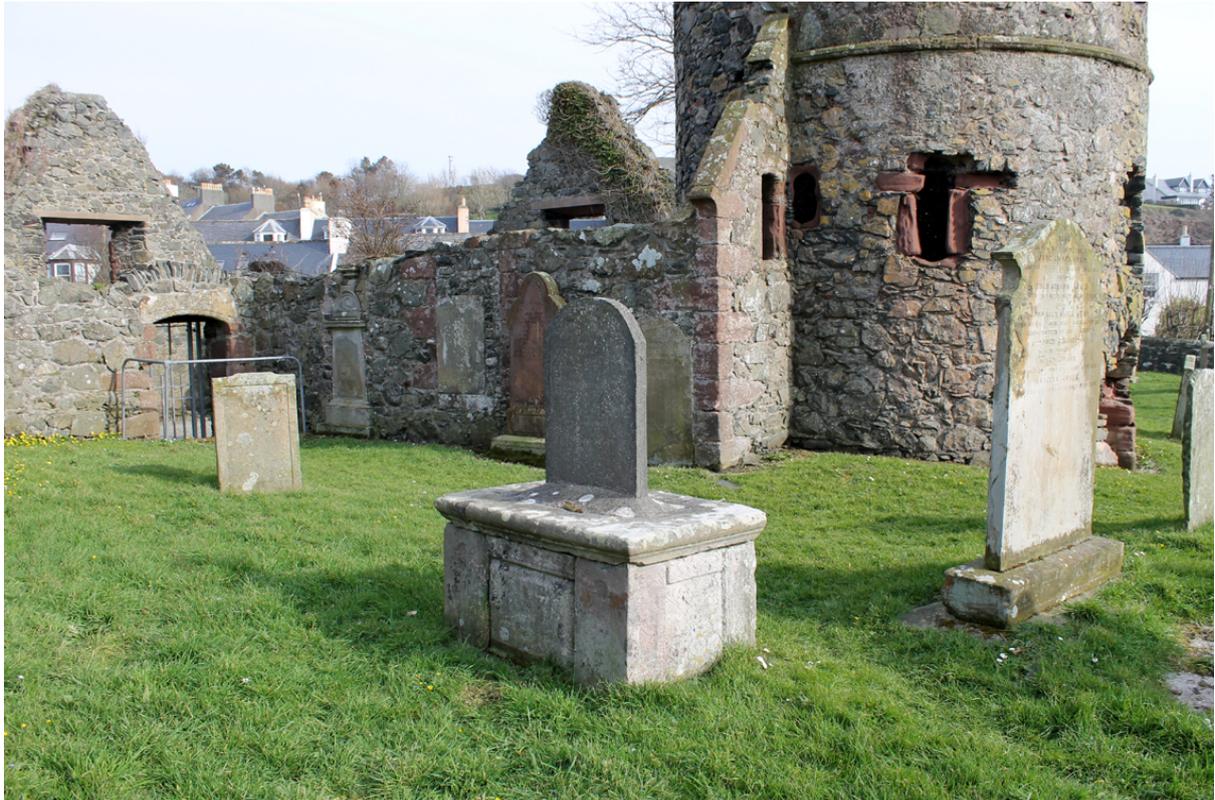
20. West transept and tower from north-west. Doorway in north transept to left.

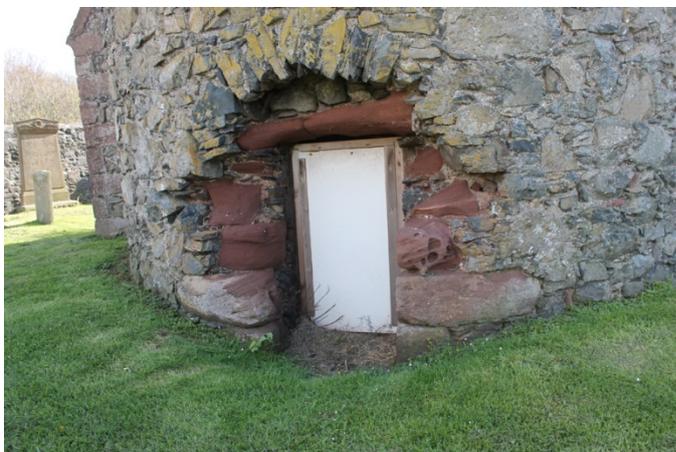
21. Tower doorway.

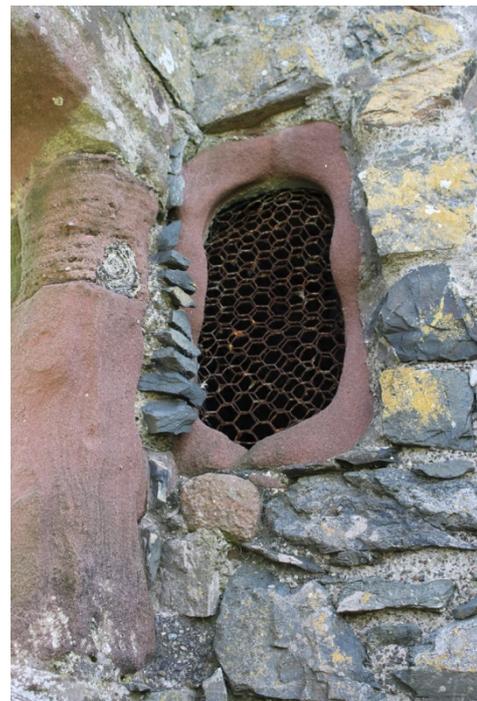
22. Tower window overlain by north-west corner wall of west transept

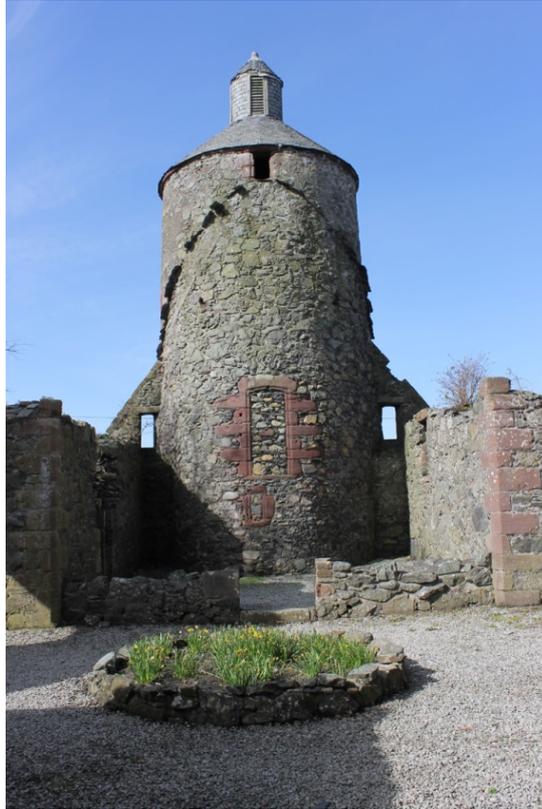
There is no internal connection between the church and tower but there are two blocked windows at first floor level. The larger window measures 1.7m x 0.6m and has the same type of curved lintel and incised decoration as seen on the west and south doors in the main church; it was probably inserted when the new church was built. The roof line of the west transept is marked on the east side of the tower by a line of broken slates beneath which is a mortar line corresponding to the transept ceiling. There are also a number of rectangular slots on the east face of the tower which held the rafters for the transept roof. Beneath the eaves on the tower's east side is a single top-floor window.

23. View of tower from east showing former roof line and west transept cross wall.

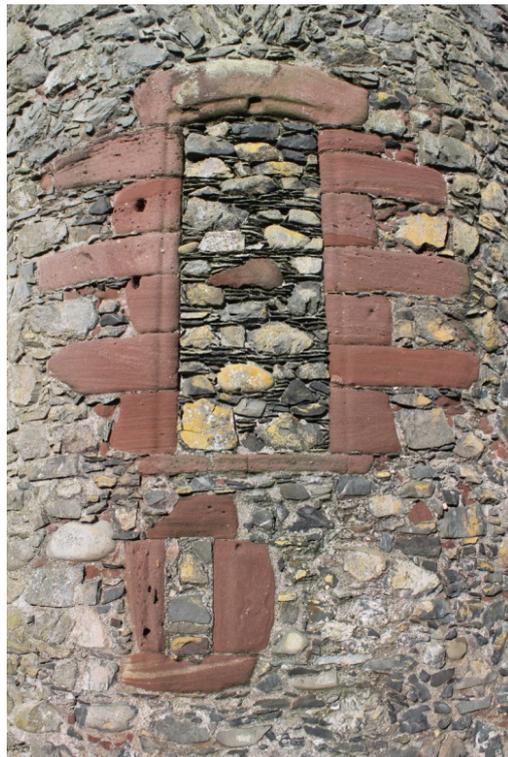
24. Detail of windows on east face of tower.
